Town of Arlington, Massachusetts

PART A – Executive Summary Self- Evaluation and Transition Plan

November 2019

Part A – Executive Summary

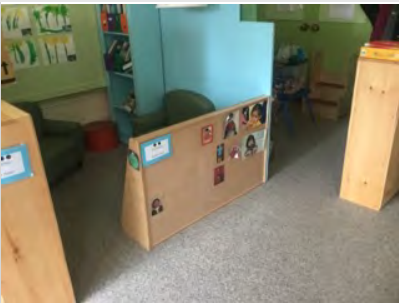
Access to Goods and Services												
16	Preschool Quiet Area	1		Interior Access Route	N/A

Route < 36" wide	20"	Ensure that a clear width of 36" min. is maintained at at lease one quiet area. Relocate furniture.	1	Labor	\$0

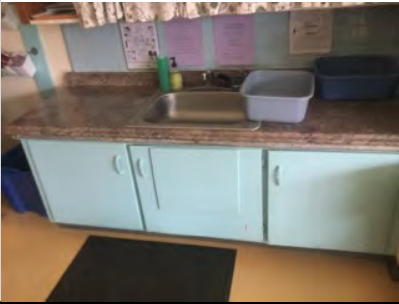
ID	Location	Floor	Room	Element	Type	Photo	Issues	Current Measure	Recommendations	Quantity	Price	Cost Estimation
Additional Access												
17	Preschool Room	1		Sinks for Children's Use	Classroom

Exposed plumbing underneath Knee or toe clearance not provided		Insulate or otherwise configure pipes to prevent contact, for at least one sink. Provide at least one sink with 25" knee and toe clearance positioned for a forward approach.	1	666	\$666
Best Practice												
18	Stairways	1

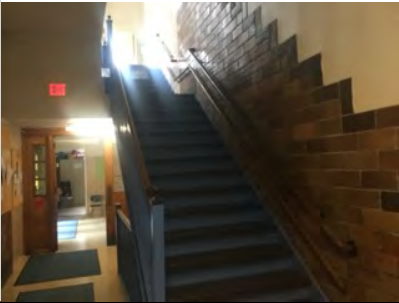
Best Practice: Update handrails for adults and children. When children are the principal users in a building or facility, a second set of handrails at an appropriate height can assist them & aid in preventing accidents. A maximum height of 28 inches measured to the top of the gripping surface from the stair nosing is recommended for handrails designed for children. 9 inches min. should be provided between handrails.	1	-	\$0

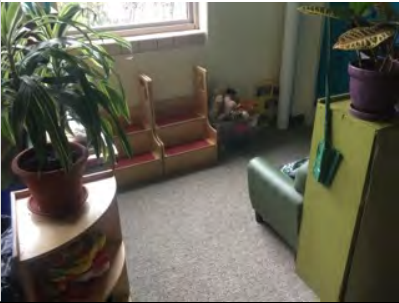
Access to Goods and Services												
19	Toddler Room	1		Interior Access Route	N/A

Route < 36" wide	32"	Ensure that a clear width of 36" min. is maintained at the accessible route. The route can narrow to 32" min., but only for 24" deep. Relocate furniture.	1	Labor	\$0
Access to Goods and Services												
20	Offices	1	4	Signage	Designation

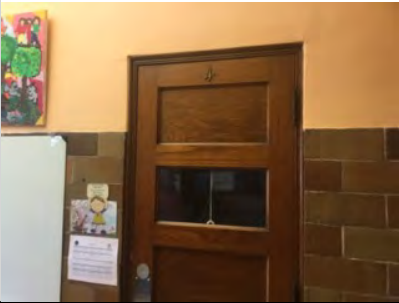
Not provided Raised characters not provided Braille not provided		Provide a sign with text with raised characters duplicated in braille. Locate signage alongside the door on the latch side.	1	116	\$116

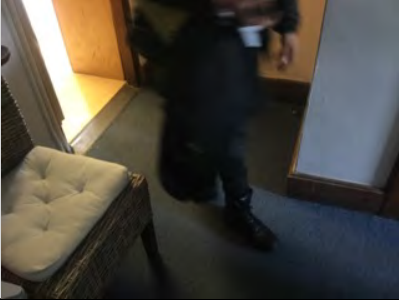
ID	Location	Floor	Room	Element	Type	Photo	Issues	Current Measure	Recommendations	Quantity	Price	Cost Estimation
21	Offices	1	4	Interior Access Route	N/A

Route < 36" wide	26"	Ensure that a clear width of 36" min. is maintained at the accessible route. Relocate the chair.	1	Labor	\$0
22	Offices	1	4	Service Counter	N/A

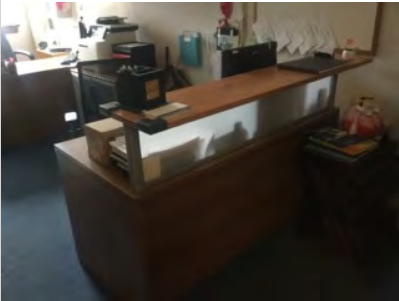
Counter > 36" high	42"	Provide a counter that is 36" max. above the ground or finished floor.	1	440	\$440
Additional Access												
23	Classroom 5	1	5	Sinks for Children's Use	Classroom

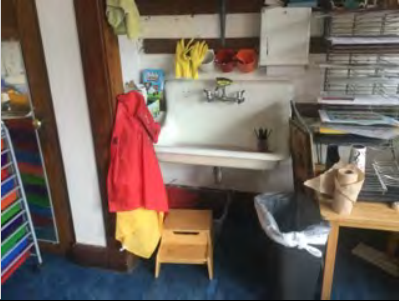
Exposed plumbing underneath Knee or toe clearance not provided	- 22"	Insulate or otherwise configure pipes to prevent contact at sink. Raise the sink 2 inches so that the rim is at 30" above the finished floor and ensure a 24" knee and toe clearance positioned for a forward approach is provided.	1	889	\$889
Access to Goods and Services												
24	All-Gender Toilet Rooms Near Classroom 10	2		Signage	Designation

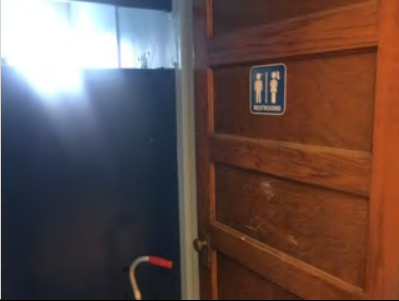
Raised characters not provided Braille not provided Sign not located on the latch side of the door International Symbol of Acc. not compliant		For both toilet rooms, provide text with raised characters duplicated in braille and locate the sign alongside the door on the latch side. Ensure that the International Symbol of Accessibility is provided after the toilet room that is brought into compliance.	2	Labor 116	\$232

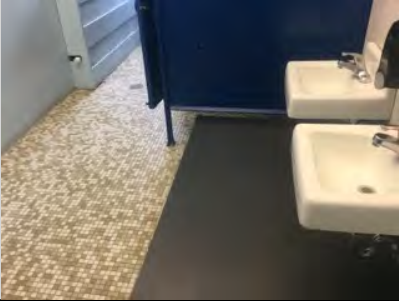
Toilet & Bathing Rooms												
25	All-Gender Toilet Rooms Near Classroom 10	2		Overall Access	Toilet Room

Accessible plumbing fixtures or stalls not provided		Provide one accessible wheelchair compartment.	1	3,091	\$3091

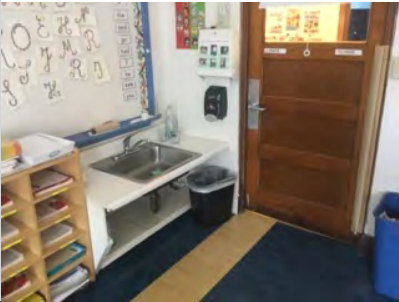
ID	Location	Floor	Room	Element	Type	Photo	Issues	Current Measure	Recommendations	Quantity	Price	Cost Estimation
Additional Access												
26	Classroom 10	2		Sinks for Children's Use	Classroom

Exposed plumbing underneath Knee or toe clearance not provided	- 18"	Insulate or otherwise configure pipes to prevent contact at sink. Raise the sink to provide 25" knee and toe clearance positioned for a forward approach.	1	889	\$889
Access to Goods and Services												
27	Classroom 12	2		Interior Access Route	N/A

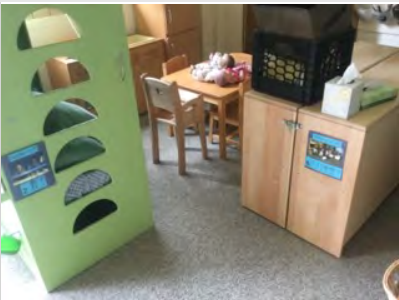
Route < 36" wide	20"	Ensure that a clear width of 36" min. is maintained at the accessible route.	1	Labor	\$0
Additional Access												
28	Classroom 12	2		Sinks for Children's Use	Classroom

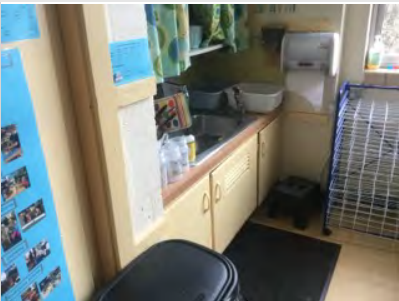
Exposed plumbing underneath Knee or toe clearance not provided		Insulate or otherwise configure pipes to prevent contact at sink. Provide at least one sink with 25" knee and toe clearance positioned for a forward approach.	1	889	\$889

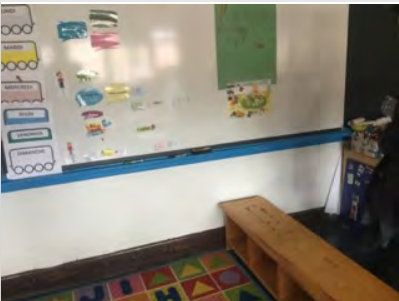
Best Practice												
29	Classroom 8	2

Best Practice: The white board is currently 32" high, consider painting the entire wall with whiteboard dry-erase paint so that small children and wheelchair users can fully utilize this area.	1	-	\$0

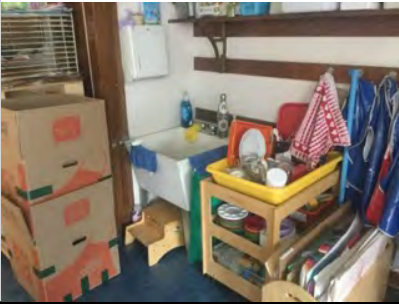
ID	Location	Floor	Room	Element	Type	Photo	Issues	Current Measure	Recommendations	Quantity	Price	Cost Estimation
Additional Access												
30	Classroom 9	2		Sinks for Children's Use	Classroom

Rim or counter at sink > 30" Knee or toe clearance not provided	33" -	Provide a new sink with the front of the rim or counter no higher than 30" and ensure the sink has 25" high min. 30" wide min. knee and toe clearance positioned for a forward approach.	1	1,547	\$1547
Access to Goods and Services												
31	Corridor	2		Operable Parts	Equipment

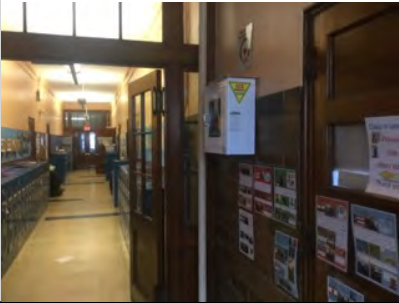
Reach < 15" or > 48"(forward/side approach)	70"	Relocate defibrillator to be no higher than 48" above finished floor.	1	128	\$128
Additional Access												
32	Drinking Fountain Near Toilet Rooms	2		Drinking Fountains	Low

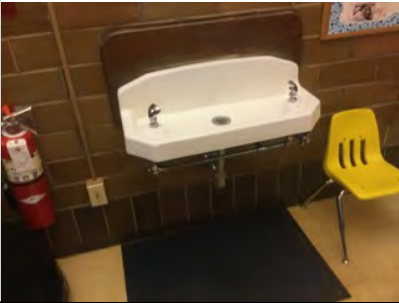
No drinking fountain provided for standing users	29"	Install a Hi-Lo drinking fountain.	1	2,108	\$2108
Access to Goods and Services

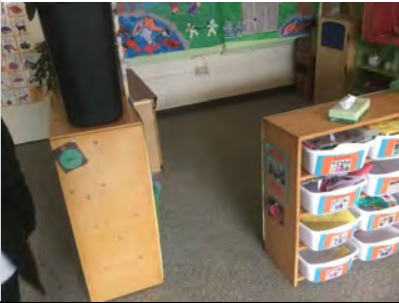
33	Preschool Room	2		Interior Access Route	N/A

Route < 36" wide	22"	Ensure that a clear width of 36" min. is maintained at the accessible route. Relocate furniture.	1	Labor	\$0

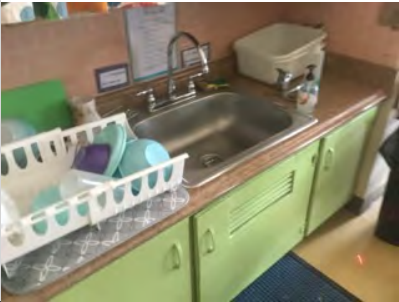
ID	Location	Floor	Room	Element	Type	Photo	Issues	Current Measure	Recommendations	Quantity	Price	Cost Estimation
Additional Access												
34	Preschool Room	2		Sinks for Children's Use	Classroom

Exposed plumbing underneath Knee or toe clearance not provided		Insulate or otherwise configure pipes to prevent contact at sink. Provide at least one sink with 25" knee and toe clearance positioned for a forward approach.	1	889	\$889
Access to Goods and Services												
35	Route to Preschool Offices	2		Interior Access Route	N/A

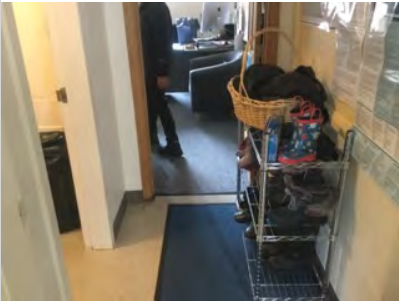
Route < 36" wide	30"	Ensure that a clear width of 36" min. is maintained at the accessible route.	1	Labor	\$0
Access to Goods and Services												
36	'School Age' Toilet Room	2		Signage	Designation

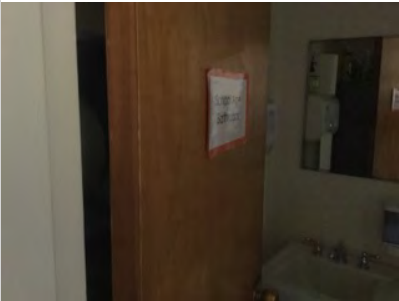
Raised characters not provided Braille not provided Sign not located on the latch side of the door International Symbol of Acc. not compliant		Provide text with raised characters duplicated in braille. Locate sign alongside the door on the latch side. Replace sign with a sign containing the International Symbol of Accessibility after the toilet room is brought into compliance.	1	Labor 116	\$116

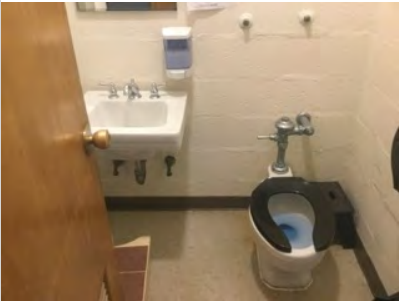
Toilet & Bathing Rooms												
37	'School Age' Toilet Room	2		Overall Access	Toilet Room

Turning space not provided Accessible plumbing fixtures or stalls not provided		Based on the toilet measurements, this toilet room is designed for students in the 4-6 grade. It lacks clear floor space and turning space and will need to be expanded and rebuilt into an accessible single-user toilet room.	1	12,302	\$12302

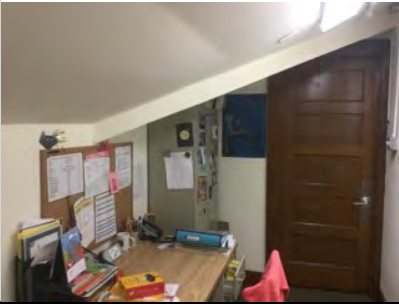
ID	Location	Floor	Room	Element	Type	Photo	Issues	Current Measure	Recommendations	Quantity	Price	Cost Estimation
Access to Goods and Services												
38	Speech Therapy Room and Other Third Floor Areas	3		Interior Access Route	N/A

Obstructed by protruding objects		Due to the limited head clearance, we do not recommend providing Town programs and services on this level.	1	-	\$0
Approach and Entrance												
39	Main Entrance	Ext.		Entrance	Main Entrance

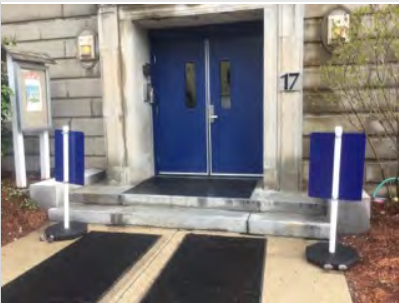
Number of public accessible entrances < 60% Entrance not on an accessible route		Remove steps. Provide a 1:50 (2.00%) level landing that is 60" deep minimum. Provide a walkway that is sloped no greater than 1:20 (5.00%) from the street to the entry landing. Renovate the east path to connect with the main path in the diagram. Remove part of fence and relocate building signage. (Cost estimate for 450 square feet of concrete walkways.)	1	6,900	\$6900

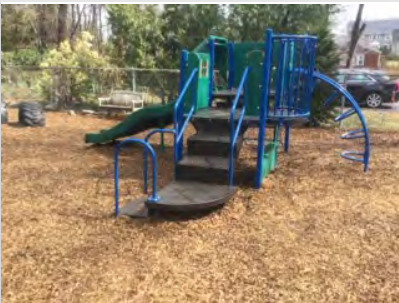
Play and Sport Areas												
40	Northern Playground	Ext.		Play Areas	N/A

Accessible route not provided to each play component No compliant transfer system	- 9"	Provide an accessible route that is 60" min. wide to each play component. Transfer system is required to be between 11 and 18" high. Alteration to transfer system might be technically infeasible, however should be considered when the area around the structure is resurfaced. (Cost estimate for 275' of poured-in-place rubber surface that is 60" wide min.)	1	19,250	\$19250
Best Practice												
41	Northern Playground	Ext.

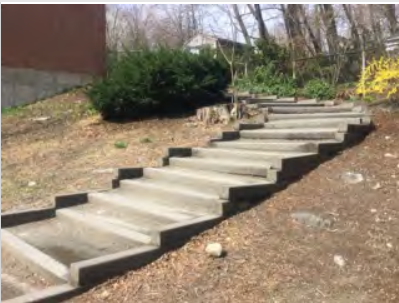
Best Practice: provide handrails at stair.	1	-	\$0

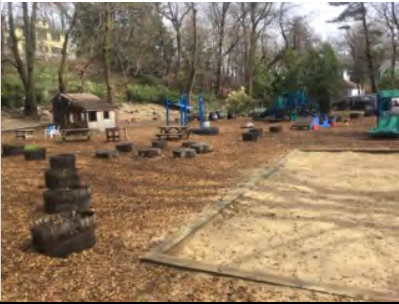
ID	Location	Floor	Room	Element	Type	Photo	Issues	Current Measure	Recommendations	Quantity	Price	Cost Estimation
Play and Sport Areas												
42	Northern Playground Routes Between Playground Structures	Ext.		Play Areas	N/A

Accessible route not provided around the playground		Provide a 374' route around the playground that is 48" wide minimum. (Cost estimate for 374 linear-foot asphalt surface.)	1	12,716	\$12716
Approach and Entrance												
43	Preschool Entrance Route (West)	Ext.		Exterior Access Route	Exterior

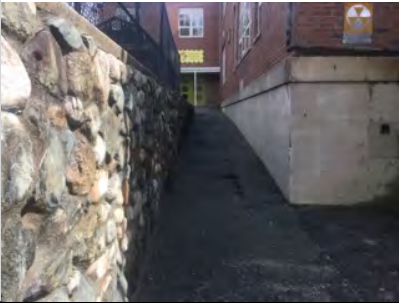
Running slope > 1:20 (5%)	8.3%	Build a compliant concrete ramp with compliant landings and handrails leading to this entrance. (Cost estimate for a 70' straight concrete ramp.)	1	82,766	\$82766
Approach and Entrance												
44	Preschool Entrance (West)	Ext.		Entrance	Main Entrance

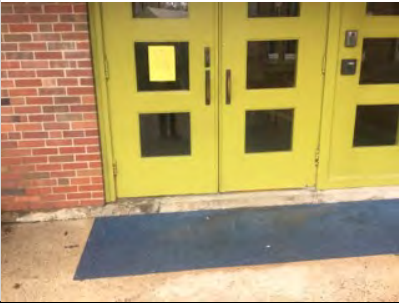
Threshold > 1/2" high	4"	Ensure that the new ramp, mentioned in the previous record addresses the 4' threshold at this entrance.	1	-	\$0

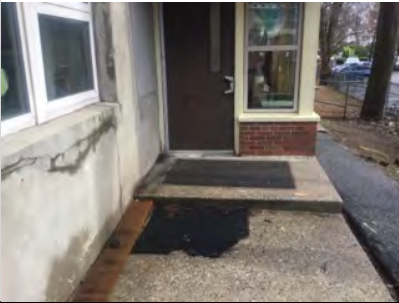
Approach and Entrance												
45	Preschool Exit on East From Classroom	Ext.		Exterior Access Route	Walkway

Level changes > 1/4"	3"	Alter change in level to be 1/4" high max. Provide a sloped route to the entrance. (Cost estimate for 5' long sloped concrete walkway.)	1	230	\$230

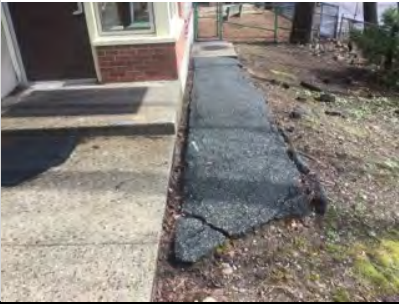
ID	Location	Floor	Room	Element	Type	Photo	Issues	Current Measure	Recommendations	Quantity	Price	Cost Estimation
Approach and Entrance												
46	Route to Northern Playground From Preschool	Ext.		Exterior Access Route	Exterior

Accessible route not provided		Provide a 48" wide accessible route to the playground. (Cost estimate for 25' asphalt route.)	1	850	\$850
Additional Access												
47	West Playground	Ext.		Drinking Fountains	Hi-Lo

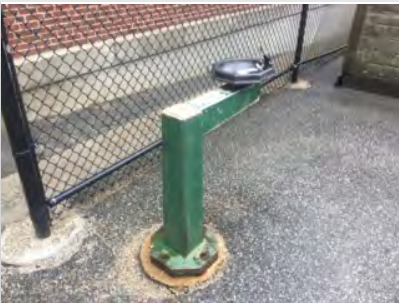
Inadequate water flow No drinking fountain provided for standing users	- -	Install a Hi-Lo drinking fountain.	1	2108	\$2108
Access to Goods and Services												
48	Cafeteria	LL		Interior Access Route	N/A

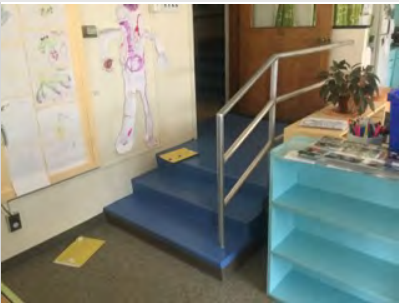
Accessible route not provided		Provide a Limited Use/Limited Access Lift between the Cafeteria and Basement.	1	90,000	\$90000
Additional Access												
49	Cafeteria	LL		Sinks for Children's Use	Other

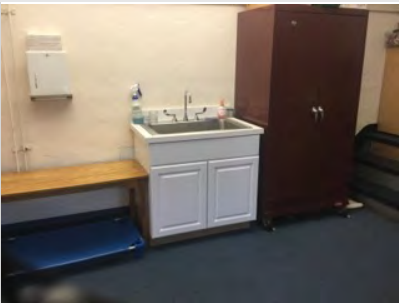
Rim or counter at sink > 30" Knee or toe clearance not provided	36" -	Relocate sink with the front of the rim or counter no higher than 30" for children 5 years or younger. Remove cabinet and install additional bracing to provide a 25" high min. knee and toe clearance positioned for a forward approach.	1	2,167	\$2167

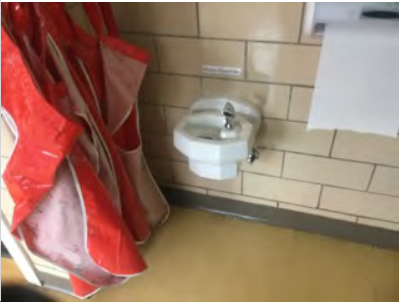
ID	Location	Floor	Room	Element	Type	Photo	Issues	Current Measure	Recommendations	Quantity	Price	Cost Estimation
Additional Access												
50	Corridor by Preschool Toilet Room	LL		Drinking Fountains	Low

No drinking fountain provided for standing users	25"	Provide an additional drinking fountain for standing users.	1	2,014	\$2014
Approach and Entrance												
51	Main Entrance	LL		Emergency Exit	N/A

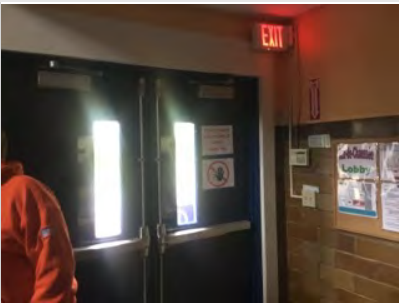
Tactile exit sign not provided International Symbol of Acc. not provided		Provide a tactile exit sign with raised characters and braille at exit doors. Mount signs between 48"- 60" above finished floor located on the latch side of the door. After the exit is made compliant, provide an illuminated sign with the International Symbol of Accessibility.	2	116	\$232
Access to Goods and Services												
52	Multi-User All-Gender Toilet Room Near Main Entrance	LL		Signage	Designation

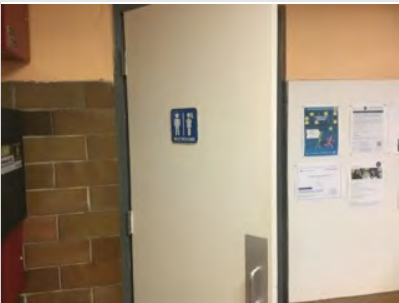
Sign not located on the latch side of the door International Symbol of Acc. not compliant		Locate sign at permanent rooms alongside the door on the latch side. Replace sign with a sign containing the International Symbol of Accessibility after the toilet room is brought into compliance.	1	Labor 116	\$116

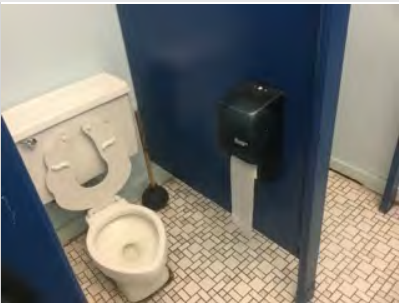
Toilet & Bathing Rooms												
53	Multi-User All-Gender Toilet Room Near Main Entrance	LL		Overall Access	Toilet Room

Accessible plumbing fixtures or stalls not provided		Provide one accessible wheelchair compartment.	1	3,091	\$3091

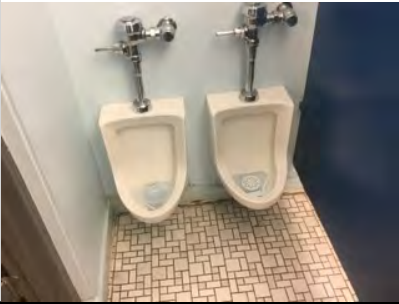
ID	Location	Floor	Room	Element	Type	Photo	Issues	Current Measure	Recommendations	Quantity	Price	Cost Estimation
Toilet Rooms for Children												
54	Multi-User All-Gender Toilet Room Near Main Entrance	LL		Urinal	N/A

Urinal recessed > 24" has > 36" clear width	34"	If urinal is recessed greater than 24" ensure there is a clear width of 36". Relocate the partition.	1	256	\$256
Approach and Entrance												
55	Preschool	LL		Emergency Exit	N/A

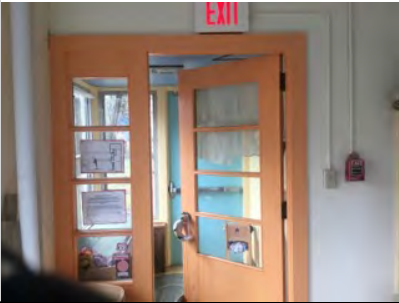
Tactile exit sign not provided International Symbol of Acc. not provided		Provide a tactile exit signs with raised characters and braille at exit doors. Mount signs between 48"- 60" above finished floor located on the latch side of the door. Provide an illuminated sign with the International Symbol of Accessibility.	2	116	\$232
Access to Goods and Services												
56	Preschool	LL		Operable Parts	Equipment

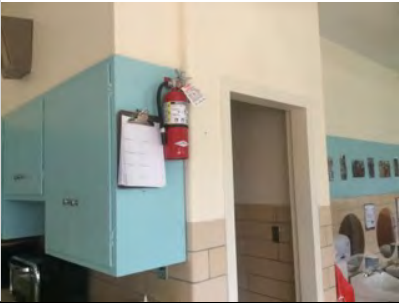
Reach < 15" or > 48"(forward/side approach)	70"	Relocate fire extinguisher to be no higher than 48" above finished floor.	1	128	\$128

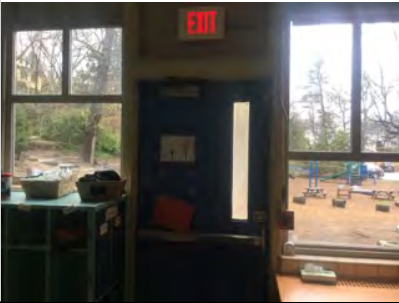
Approach and Entrance												
57	Preschool Exit on North	LL		Emergency Exit	N/A

Emergency exit not on an accessible route Tactile exit sign not provided Directional sign to accessible emergency exit not provided		Provide a directional sign indicating the location of the nearest emergency exit. Provide a tactile exit sign with raised characters and braille at exit doors. Mount signs between 48"- 60" above finished floor located on the latch side of the door.	2	116	\$232

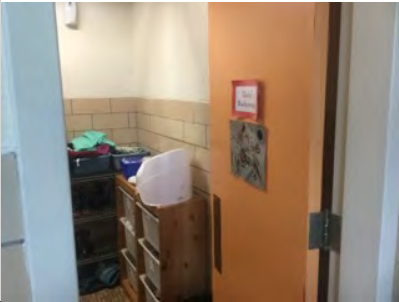
ID	Location	Floor	Room	Element	Type	Photo	Issues	Current Measure	Recommendations	Quantity	Price	Cost Estimation
Access to Goods and Services												
58	Preschool Girls' Toilet Room	LL		Signage	Designation

Not provided Raised characters not provided Braille not provided		Provide a sign with text with raised characters duplicated in braille. Locate signage alongside the door on the latch side.	1	116	\$116
Toilet & Bathing Rooms												
59	Preschool Girls' Toilet Room	LL		Overall Access	Toilet Room

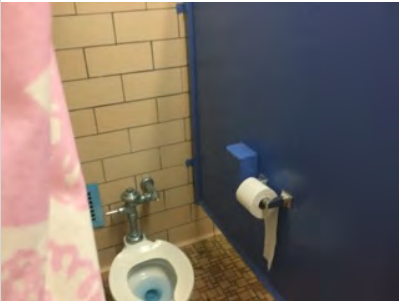
Accessible plumbing fixtures or stalls not provided		Provide one accessible wheelchair compartment.	1	3,091	\$3091
Access to Goods and Services												
60	Preschool Toilet Room	LL		Signage	Designation

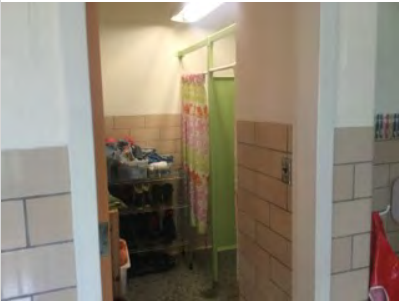
Not provided Raised characters not provided Braille not provided		Provide a sign with text with raised characters duplicated in braille. Locate signage alongside the door on the latch side.	1	116	\$116

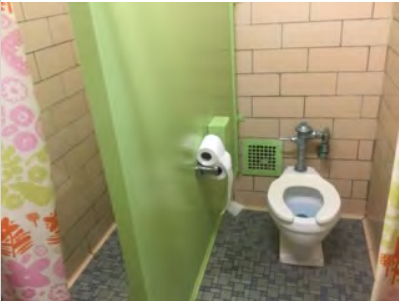
Toilet & Bathing Rooms												
61	Preschool Toilet Room	LL		Overall Access	Toilet Room

Accessible plumbing fixtures or stalls not provided		Provide one accessible wheelchair compartment.	1	3,091	\$3091

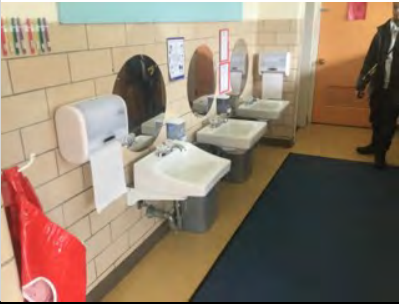
ID	Location	Floor	Room	Element	Type	Photo	Issues	Current Measure	Recommendations	Quantity	Price	Cost Estimation
Toilet Rooms for Children												
62	Preschool Toilet Room	LL		Lavatory	N/A

Toe or knee clearances not provided Exposed plumbing underneath	22"	Provide at least one lavatory with 25" min. knee clearance positioned for a forward approach. Ensure toe clearance is also provided. Insulate or otherwise configure pipes to prevent contact at this lavatory.	1	889	\$889
Access to Goods and Services												
63	Vertical Circulation	LL 1 2		Interior Access Route	N/A

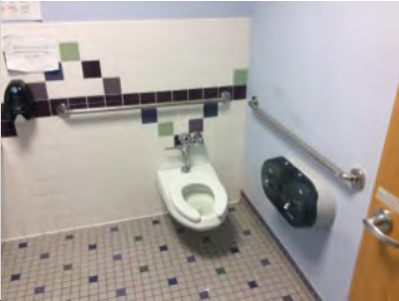
ID	Location	Floor	Room	Element	Type	Photo	Issues	Current Measure	Recommendations	Quantity	Price	Cost Estimation
Toilet Rooms for Children												
1	First Floor Boys' Toilet Room	1		Single-User Toilet	N/A

Centerline < 12" or > 15" (K - 3) Side or rear grab bar < 20" or > 25" high (K - 3)	19" 35.5"	Relocate toilet so that the centerline is 15" from the side wall. Locate grab bars 25" above the finished floor.	1	1542	\$1542
2	First Floor Boys' Toilet Room	1		Lavatory	N/A

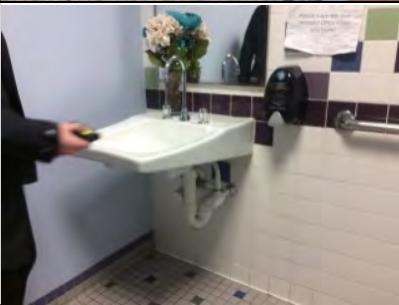
Lavatory rim or counter > 30" Mirror above lavatory w/reflective surface > 31"	34" 40"	Relocate lavatory with the front of the rim or counter no higher than 30". Lower mirror so that the bottom surface is at 31" above finished floor.	1	256	\$256
Toilet Rooms for Children												
3	First Floor Girls' Toilet Room	1		Single-User Toilet	N/A

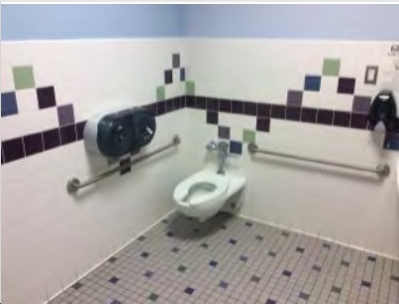
Side or rear grab bar < 42" long Non-compliant toilet paper dispenser	36" -	Provide a side wall grab bar that is 42" long located 6" max. from the interior corner. Relocate toilet paper dispenser so that it is 14" above the finished floor and between 7"- 9" in front of the toilet. Ensure dispensers and other devices are not mounted above grab bars.	1	802	\$802

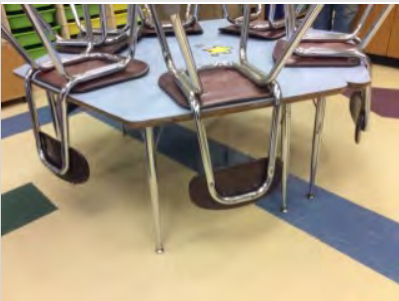
Access to Goods and Services												
4	Kindergarten Classroom	1		Dining or Work Surfaces	Work Surface

At least one or 5% accessible tables not provided	21"	Ensure that at least one work surface is accessible. An accessible work surface must have a knee clearance of 24" high and 30" wide.	1	350	\$350
5	Kindergarten Classroom	1		Interior Access Route	N/A

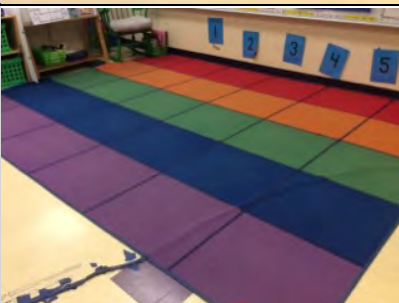
Mat not securely attached	-	Securely attach mat.	1	Labor	\$0

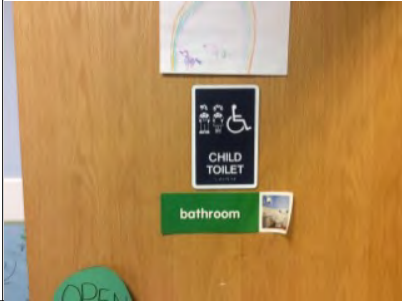
ID	Location	Floor	Room	Element	Type	Photo	Issues	Current Measure	Recommendations	Quantity	Price	Cost Estimation
Access to Goods and Services												
6	Kindergarten Toilet Room	1		Signage	Designation

Sign not located on the latch side of the door	-	Locate sign at permanent rooms alongside the door on the latch side.	1	Labor	\$0
Toilet Rooms for Children												
7	Kindergarten Toilet Room	1		Single-User Toilet	N/A

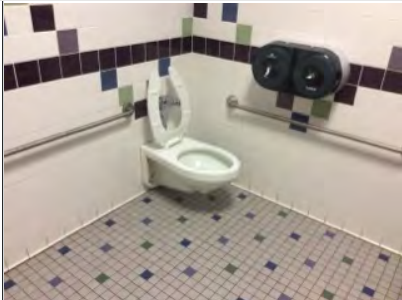
Non-compliant toilet paper dispenser	-	Relocate toilet paper dispenser so that it is 14" above the finished floor and between 7"- 9" in front of the toilet. Ensure dispensers and other devices are not mounted above grab bars.	1	353	\$353
8	Kindergarten Toilet Room	1		Dispensers	Paper Towel Dispenser

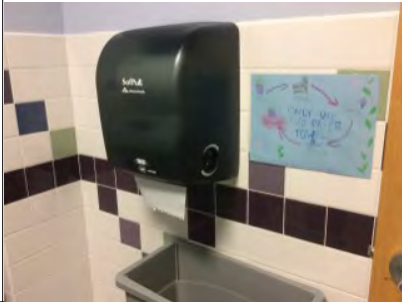
Dispenser acts as a protruding object	-	Relocate dispenser out of the circulation path.	1	353	\$353
Access to Goods and Services												
9	Main Entrance, Exit 1	1		Means of Egress	N/A

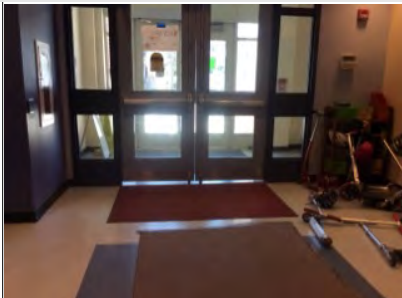
Mat not securely attached Tactile exit sign not provided Illuminated exit sign lacks international symbol of accessibility.	- - -	Securely attach mat. Provide a tactile exit sign with raised characters and braille at the the exit doors. Mount the sign between 48"- 60" above the finished floor to the right side of the right hand door. Provide an illuminated exit sign with the International Symbol of Accessibility (ISA) at accessible exits.	2	116	\$232

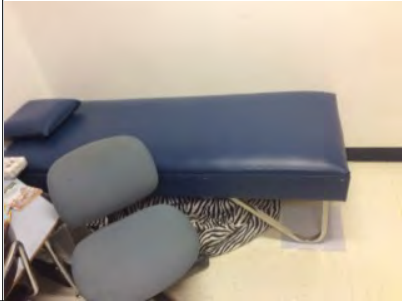
ID	Location	Floor	Room	Element	Type	Photo	Issues	Current Measure	Recommendations	Quantity	Price	Cost Estimation
Best Practice												
10	Nurse's Office	1		N/A	N/A

Best Practice: Consider providing an adjustable height bed.	1	0	\$0
Toilet Rooms for Children												
11	Nurse's Office Toilet Room	1		Single-User Toilet	N/A

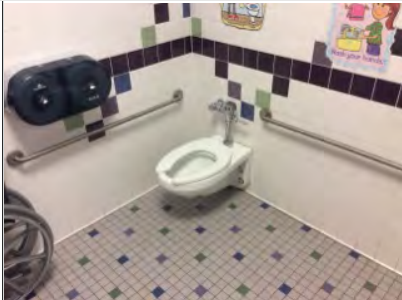
Non-compliant toilet paper dispenser	-	Relocate toilet paper dispenser so that it is 14" above the finished floor and between 7"- 9" in front of the toilet. Ensure dispensers and other devices are not mounted above grab bars.	1	353	\$353
12	Nurse's Office Toilet Room	1		Dispensers	Paper Towel Dispenser

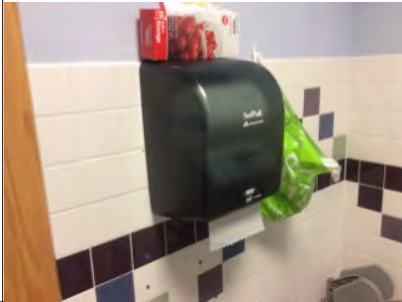
Dispenser acts as a protruding object	-	Relocate dispenser out of the circulation path.	1	353	\$353
13	Nurse's Office Toilet Room	1		Single-User Toilet	N/A

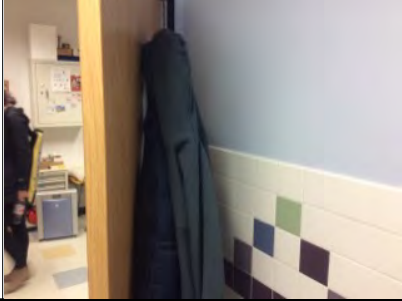
Coat hook not within reach range	68"	Lower hook so that it is no higher than 40" above the floor.	1	75	\$75

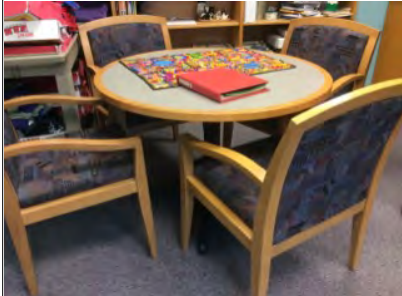
Access to Goods and Services												
14	Principal's Office	1		Dining or Work Surfaces	Work Surface

Knee or toe clearance not provided	23"	Provide at least 1 work surface with 27" min. knee and toe clearance for parents and children.	1	350	\$350

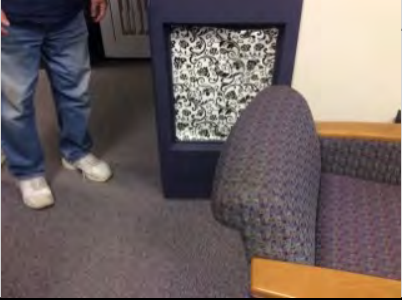
ID	Location	Floor	Room	Element	Type	Photo	Issues	Current Measure	Recommendations	Quantity	Price	Cost Estimation
15	Principal's Office	1		Doors, Doorways, & Gates	Office

Maneuvering clearance(s) not provided	15"	Relocate the armchair to allow for 18" clear on the latch pull side of the door.	1	Labor	\$0
Access to Goods and Services												
16	Conference Room and Principal's Office	1	104	Signage	Designation

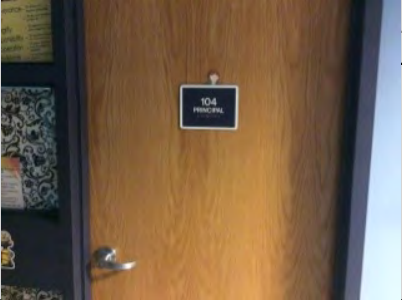
Braille not provided Sign not located on the latch side of the door	- -	Provide braille. Locate sign at permanent rooms alongside the door on the latch side.	2	116	\$232
Access to Goods and Services												
17	Peirce Playcare Room	1	121	Doors, Doorways, & Gates	Classroom

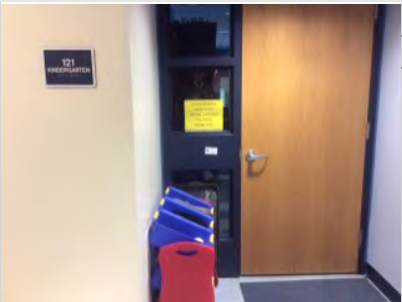
Maneuvering clearance(s) not provided Mat not securely attached	- -	Relocate bins. Securely attach mat.	1	Labor	\$0
18	Peirce Playcare Room	1	121	Interior Access Route	N/A

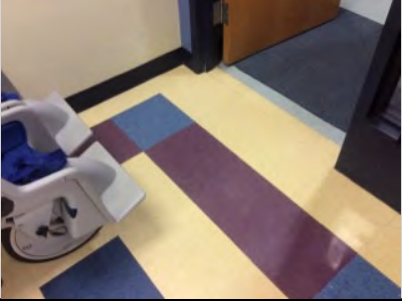
Route < 36" wide	31"	Ensure that a clear width of 36" min. is maintained at the accessible route. Relocate furniture.	1	Labor	\$0

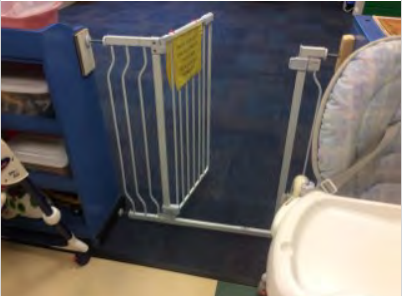
Best Practice												
19	Peirce Playcare Room	1	121		N/A

Best Practice: Recommend providing a gate that has 32" min clear width and a threshold that is 1/2" max. and hardware that can be operable with a closed fist. If the gate is used by members of the public, an accessible gate must be provided.	1	-	\$0

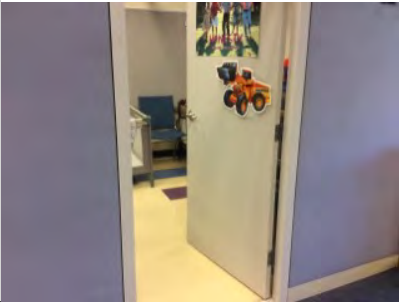
ID	Location	Floor	Room	Element	Type	Photo	Issues	Current Measure	Recommendations	Quantity	Price	Cost Estimation
Access to Goods and Services												
20	Peirce Playcare Room, Crib Area	1	121	Doors, Doorways, & Gates	Circulation

Clear width at door < 32"	31"	Use offset hinges to ensure that the door has 32" clear minimum.	1	1116	\$1116
21	Peirce Playcare Room, Crib Area	1	121	Interior Access Route	N/A

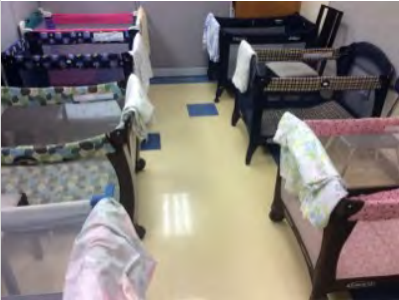
Route < 36" wide	32"	Ensure that a clear width of 36" min. is maintained at the accessible route. Rearrange cribs. Route can narrow to 32" for 24" of depth.	1	Labor	\$0
Best Practice												
22	Peirce Playcare Room, Toilet Room	1	121

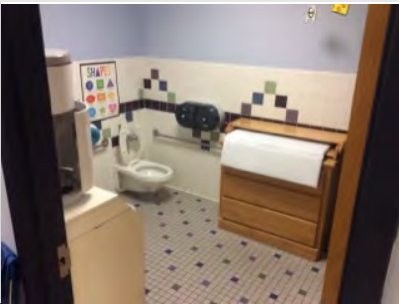
-	Best Practice: Toilet is listed as a staff toilet room on floor plans. If it is used by children, remove furniture that obstructs maneuvering clearance at the door and clear floor space at the toilet and relocate the toilet paper dispenser underneath the grab bar.	1	-	\$0

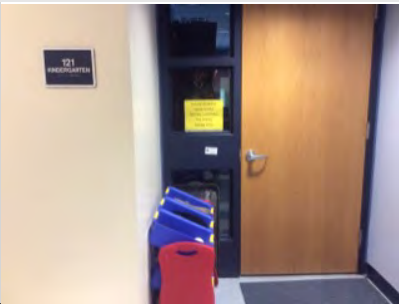
Best Practice												
23	Peirce Playcare, Conf. Room and Principal's Office, Office, Literacy Lounge, Personal Library, Office	1 2 3	121 104 222 224 323 322

-	Best Practice: Some signs also do not reflect the program observed by IHCD staff at the time of review. If a room permanently changes its program, update the designation signage to reflect the current program.	7	-	\$0

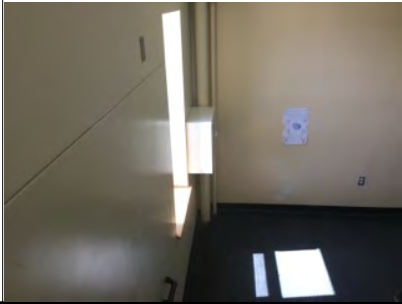
ID	Location	Floor	Room	Element	Type	Photo	Issues	Current Measure	Recommendations	Quantity	Price	Cost Estimation
Access to Goods and Services												
24	Stairwell 1	2		Interior Access Route	N/A

Obstructed by protruding objects	10"	Relocate white box.	1	128	\$128
Access to Goods and Services												
25	Counselor's Office	2	203	Dining or Work Surfaces	Work Surface

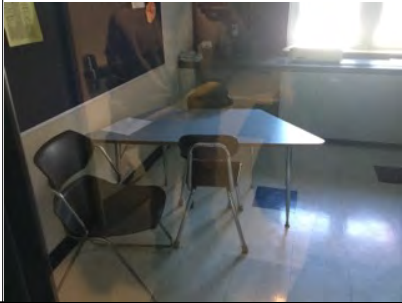
Knee or toe clearance not provided	24"	Provide at least 1 work surface to have 27" min. knee and toe clearance for parents and children.	1	350	\$350
Access to Goods and Services												
26	Classroom	2	209	Children's Reach Ranges	N/A

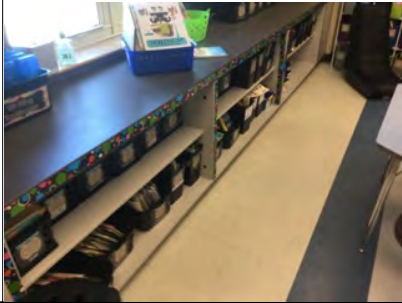
Reach < 18" or > 40" (Ages 5 - 8)	8"	Relocate so that stored materials are between 18" and 40" above finished floor.	1	Labor	\$0
Additional Access												
27	Classroom	2	209	Sinks for Children's Use	Classroom

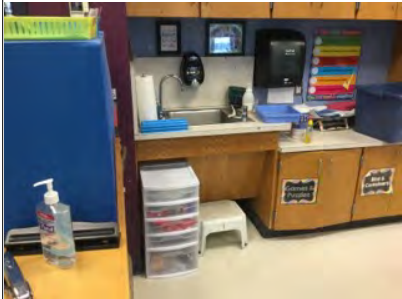
Knee or toe clearance not provided	-	Remove items from underneath sink to allow for toe clearance.	1	Labor	\$0

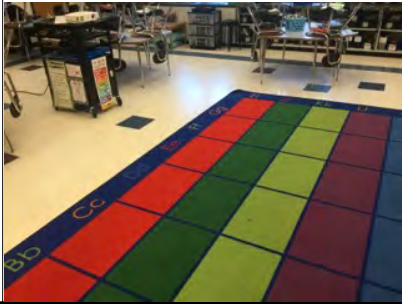
ID	Location	Floor	Room	Element	Type	Photo	Issues	Current Measure	Recommendations	Quantity	Price	Cost Estimation
Access to Goods and Services												
28	Classrooms Throughout the School	2	209, 217	Interior Access Route	N/A

Mat not securely attached	-	Securely attach mats throughout the school. Ensure at least one classroom per grade has all required accessibility features.	5	Labor	\$0
Additional Access												
29	Classroom	2	211	Sinks for Children's Use	Classroom

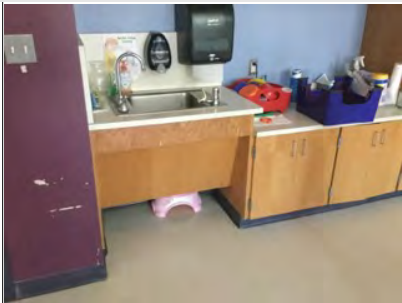
Knee or toe clearance not provided	-	Remove items from underneath sink to allow for toe clearance.	1	Labor	\$0
Access to Goods and Services												
30	Classroom	2	218	Interior Access Route	N/A

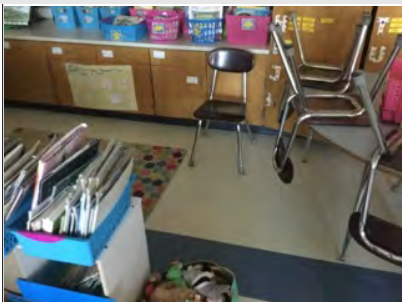
Route < 36" wide	25"	Ensure that a clear width of 36" min. is maintained at the accessible route. Relocate furniture.	1	Labor	\$0
Access to Goods and Services												
31	Offices	2	222	Signage	Designation

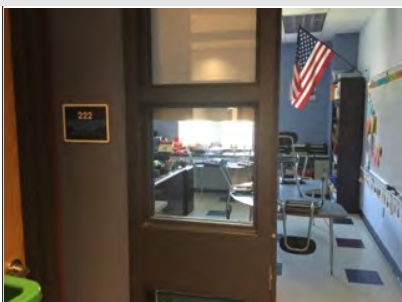
Not provided	-	There are multiple instances where pieces of tape are placed over the raised characters and braille provided. Ensure the pieces of tape are removed and that the braille and raised characters are not covered.	1	Labor	\$0

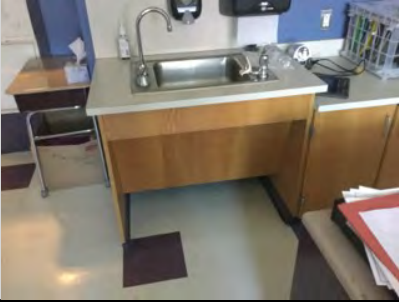
ID	Location	Floor	Room	Element	Type	Photo	Issues	Current Measure	Recommendations	Quantity	Price	Cost Estimation
Additional Access												
32	Offices	2	222	Sinks for Children's Use	Classroom

Sink not on an accessible route	24.5"	Relocate the desk that is located in the clear floor space of the sink.	1	Labor	\$0
Access to Goods and Services												
33	ELA Classroom	2	223	Dining or Work Surfaces	Work Surface

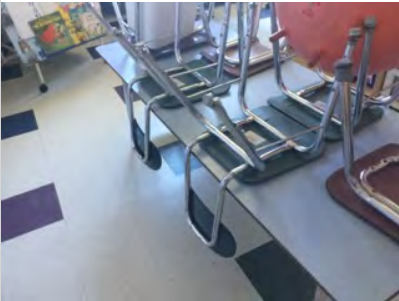
Knee or toe clearance not provided	22"	Ensure that at least one work surface is accessible. An accessible work surface must have a knee clearance of 24" high and 30" wide.	1	350	\$350
Additional Access												
34	ELA Classroom	2	223	Sinks for Children's Use	Classroom

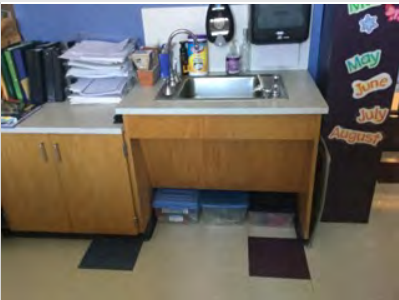
Knee or toe clearance not provided	-	Remove items from underneath sink to allow for toe clearance.	1	Labor	\$0
Best Practice												
35	ELA Classroom	2	223	N/A	N/A

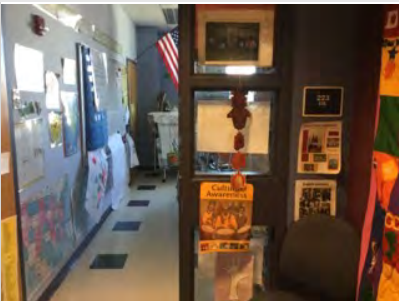
Best Practice: Consider removing some of the additional posters so that the room signage is easier to locate.	1	0	\$0

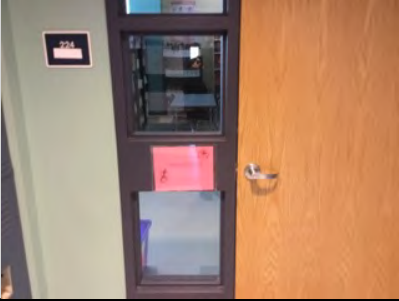
ID	Location	Floor	Room	Element	Type	Photo	Issues	Current Measure	Recommendations	Quantity	Price	Cost Estimation
Access to Goods and Services												
36	Literacy Lounge	2	224	Signage	Designation

Not provided	-	There are multiple instances where pieces of tape are placed over the raised characters and braille provided. Ensure the pieces of tape are removed and that the braille and raised characters are not covered.	1	Labor	\$0
Universal Design												
37	Near Third Floor Toilet Rooms	3		N/A	N/A

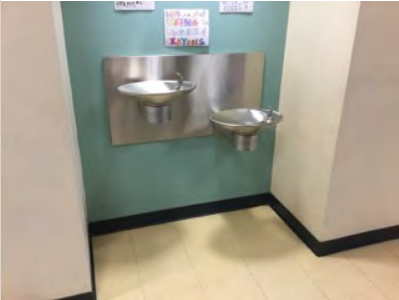
Best Practice: Good example of drinking fountains for standing and seated users that do not act as protruding objects.	1	-	\$0
Access to Goods and Services												
38	OT/PT Classroom	3	314	Signage	Designation

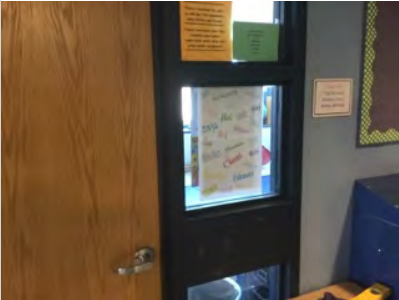
Not provided	-	Locate signage alongside the door on the latch side. Ensure it has raised characters duplicated in braille and is mounted between 48" and 60" above the finished floor.	1	116	\$116

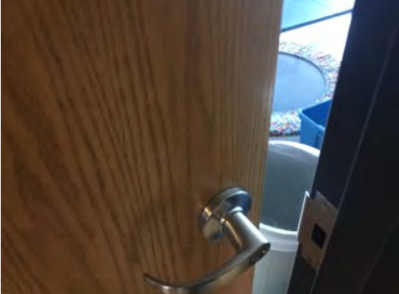
39	OT/PT Classroom	3	314	Doors, Doorways, & Gates	Classroom

Door requires > 5 lbs. of force to open	12 lbs.	Adjust closers so doors do not require more than 5 pounds of force to open.	1	Labor	\$0

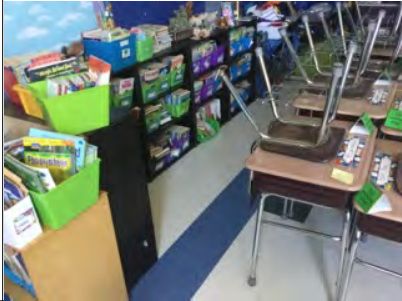
ID	Location	Floor	Room	Element	Type	Photo	Issues	Current Measure	Recommendations	Quantity	Price	Cost Estimation
Access to Goods and Services												
40	Classroom	3	318	Interior Access Route	N/A

Route < 36" wide	20"	Ensure that a clear width of 36" min. is maintained at the accessible route. Relocate furniture.	1	Labor	\$0
Access to Goods and Services												
41	Office	3	322	Signage	Designation

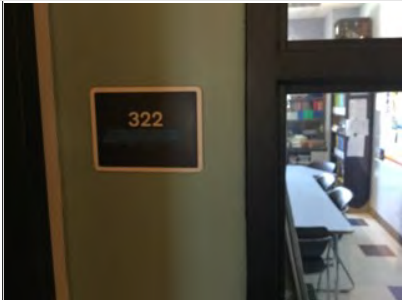
Not provided	-	There are multiple instances where pieces of tape are placed over the raised characters and braille provided. Ensure the pieces of tape are removed and that the braille and raised characters are not covered.	1	Labor	\$0
42	Office	3	322	Dining or Work Surfaces	Work Surface

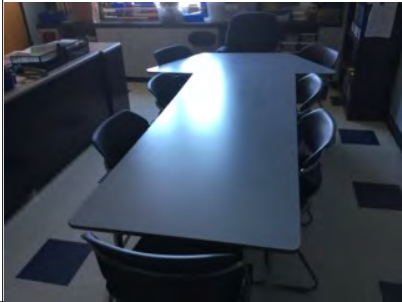
Knee or toe clearance not provided	26"	Provide at least 1 work surface with 27" min. knee and toe clearance for parents and children.	1	350	\$350
43	Office	3	322	Interior Access Route	N/A

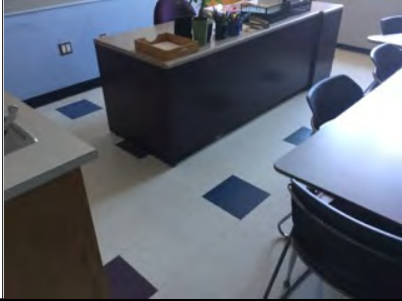
Route < 36" wide	26"	Ensure that a clear width of 36" min. is maintained at the accessible route. Relocate furniture.	1	Labor	\$0

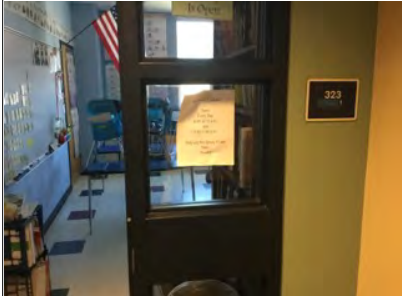
Access to Goods and Services												
44	Personal Library	3	323	Signage	Designation

Not provided	-	There are multiple instances where pieces of tape are placed over the raised characters and braille provided. Ensure the pieces of tape are removed and that the braille and raised characters are not covered.	1	Labor	\$0

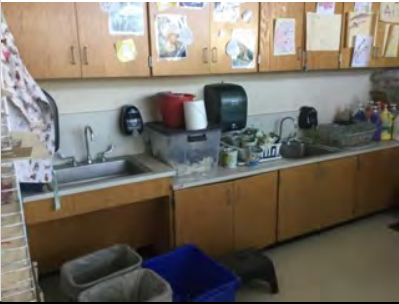
ID	Location	Floor	Room	Element	Type	Photo	Issues	Current Measure	Recommendations	Quantity	Price	Cost Estimation
Additional Access												
45	Art Classroom	3	324	Sinks for Children's Use	Classroom

Sink not on an accessible route	-	Remove items from underneath sink to allow for toe clearance.	1	Labor	\$0
Access to Goods and Services												
46	Grade 1-5 Classrooms Throughout School	3, 2		Dining or Work Surfaces	Work Surface

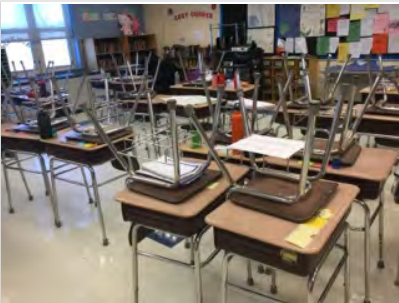
At least one or 5% accessible tables not provided	19" wide	Ensure that at least one work surface per classroom per grade is accessible and integrated into the classroom. An accessible desk must have a knee clearance of 24" high and 30" wide.	5	350	\$1750
Toilet Rooms for Children												
47	Second and Third Floor Boys' Toilet Rooms	3, 4		Toilet Compartment	Accessible Compartment

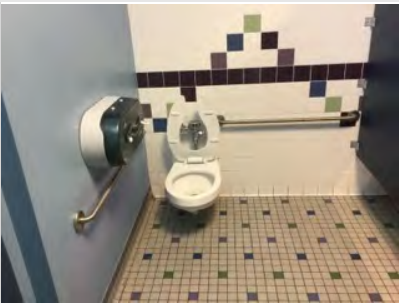
Non-compliant toilet paper dispenser	-	Relocate toilet paper dispenser so that it is 14" above the finished floor and between 7"- 9" in front of the toilet. Ensure dispensers and other devices are not mounted above grab bars.	2	353	\$706

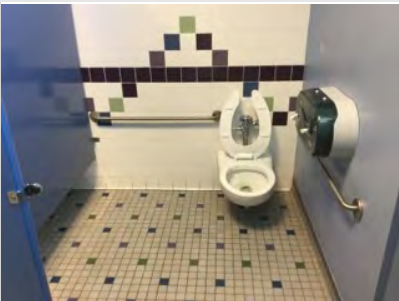
Toilet Rooms for Children												
48	Second and Third Floor Girls' Toilet Rooms	3, 4		Toilet Compartment	Accessible Compartment

Non-compliant toilet paper dispenser	-	Relocate toilet paper dispenser so that it is 14" above the finished floor and between 7"- 9" in front of the toilet. Ensure dispensers and other devices are not mounted above grab bars.	2	353	\$706

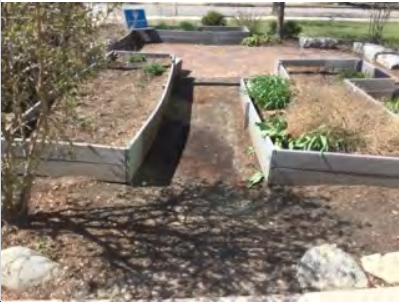
ID	Location	Floor	Room	Element	Type	Photo	Issues	Current Measure	Recommendations	Quantity	Price	Cost Estimation
Approach and Entrance												
49	Community Garden, Northwest Side	Ext.		Exterior Access Route	Exterior

Accessible route not provided	-	Ensure an accessible route is provided to the community garden. (Cost based on a 15' stone dust route provided to the community garden with a 1:20 [5%] max. running slope.)	1	342	\$342
Access to Goods and Services												
50	Exit 2	Ext.		Means of Egress	N/A

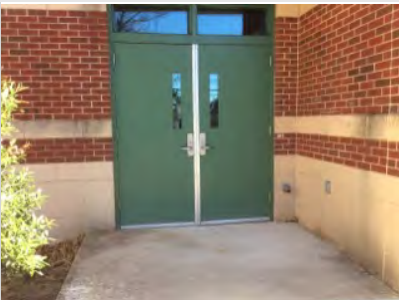
Tactile exit sign not provided Directional sign to accessible emergency exit not provided	- -	Provide a tactile exit sign with raised characters and braille at the interior of the exit doors. Mount the sign between 48"- 60" above the finished floor to the right of the right hand door. Provide a directional sign at the interior of the exit doors indicating the location of the nearest emergency exit.	2	116	\$232

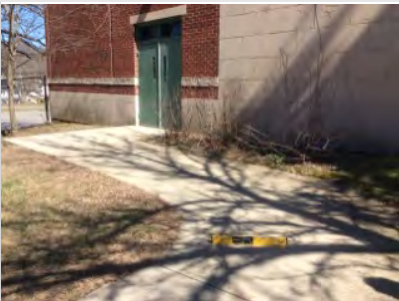
Approach and Entrance												
51	Exit 3	Ext.		Exterior Access Route	Exterior

Cross slope > 1:50 (2.00%)	10.1%	Reduce cross slope to be no steeper than 1:50 (2.00%). (Cost based on 20' concrete to adjust slope.)	1	1000	\$1000
Approach and Entrance												
52	Parking Lot Along Newland Road	Ext.		Off-Street Parking Lot or Garage	N/A

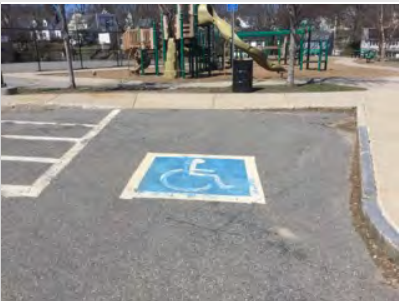
Running or cross slope at space > 1:50 (2.00%) Sign does not have the designation "Van Accessible"	7.2% -	Reduce the running slope to be no steeper than 1:50 (2.00%). Add the designation "Van Accessible" to the sign located at the van accessible space. (Cost based on leveling surface and adding a sign.)	1	970	\$970

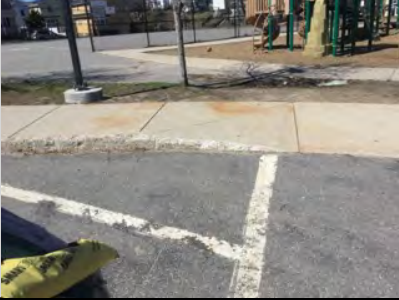
ID	Location	Floor	Room	Element	Type	Photo	Issues	Current Measure	Recommendations	Quantity	Price	Cost Estimation
53	Parking Lot Along Newland Road	Ext.		Off-Street Parking Lot or Garage	N/A

Access aisle does not adjoin an accessible route	-	Ensure the access aisle adjoins an accessible route. (Cost based on restriping space so that access aisle is on the right side and adjoins with curb cut.)	1	150	\$150
Play and Sport Areas												
54	Playground with Climbing Structure North of Basketball Court	Ext.		Play Areas	N/A

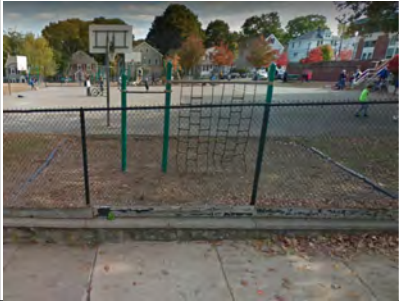
Accessible route not provided to play components Accessible route not provided around the playground	22' 30'	Provide an accessible impact-attenuating surface that is 60" wide to play components. Provide an accessible route that is 48" wide along each side of the playground. Due to the size of the play ground, it may be technically infeasible to provide a route along the fence side. (Cost estimate based on 22' of poured in place to the play components and 30' of asphalt routes alongside the play area.)	1	2580	\$2580

- In playgrounds, IHCD strongly recommends exploring the possibility of an alternative surface to engineered wood fiber (EWF). Overtime, EWF requires continuous maintenance to ensure the surface is maintained in operable working condition (stable, firm and slip-resistant). In addition, when used in combination with other surfaces required for accessible routes to play components in Massachusetts, it will present a challenge to prevent level changes at the transition points between EWF and other surfaces, and to keep the accessible routes clear of EWF.

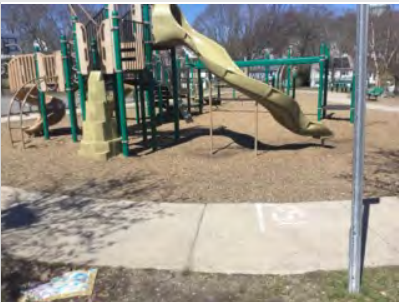
Play and Sport Areas												
55	Playground, Northeast Side of School	Ext.		Play Areas	N/A

Accessible route not provided to play components	-	Provide an accessible route to each play component. (Cost based on a 5' wide 298' long poured in place rubber to play components.)	1	20860	\$20860
Universal Design												
56	Playground, Southwest Side of School	Ext.		N/A	N/A

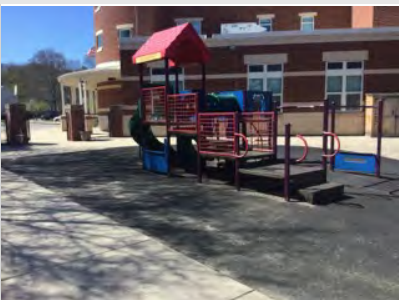
Best Practice: Good example of playground with impact resistant surfacing throughout play area, and an accessible concrete route around the playground. IHCD strongly recommends repeating this surfacing with the playground on the northeast side of the building.	1	-	\$0

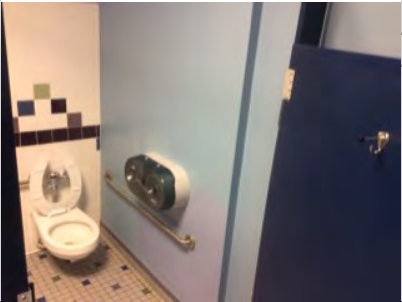
ID	Location	Floor	Room	Element	Type	Photo	Issues	Current Measure	Recommendations	Quantity	Price	Cost Estimation
Toilet Rooms for Children												
57	Boys' Multi-User Toilet Room	LL		Toilet Compartment	Accessible Compartment

Non-compliant toilet paper dispenser Coat hook not within reach range	- 59.75"	Relocate toilet paper dispenser so that it is 14" above the finished floor and between 7"- 9" in front of the toilet. Ensure dispensers and other devices are not mounted above grab bars. Lower hook so that it is no higher than 40".	1	428	\$428
58	Boys' Multi-User Toilet Room	LL		Dispensers	Paper Towel Dispenser

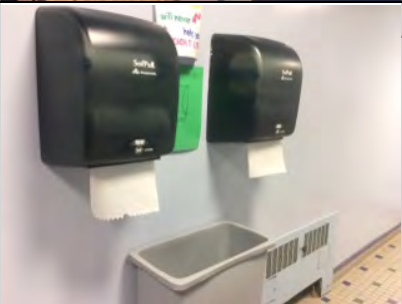
Dispenser acts as a protruding object	-	Relocate dispensers out of the circulation path.	2	353	\$706
Access to Goods and Services												
59	Exit 3	LL		Means of Egress	N/A
